Stanford in the Vale Parish Council
Objection in respect of Planning Application P24/V1091/N4B

Stanford in the Vale Parish Council objects to the application for the reasons set out below:

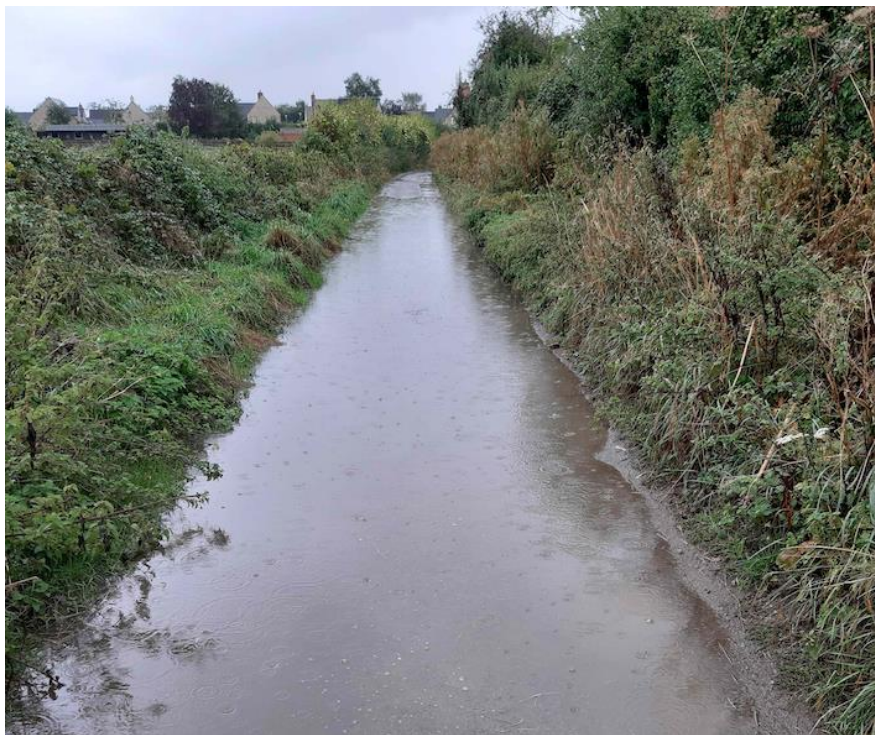
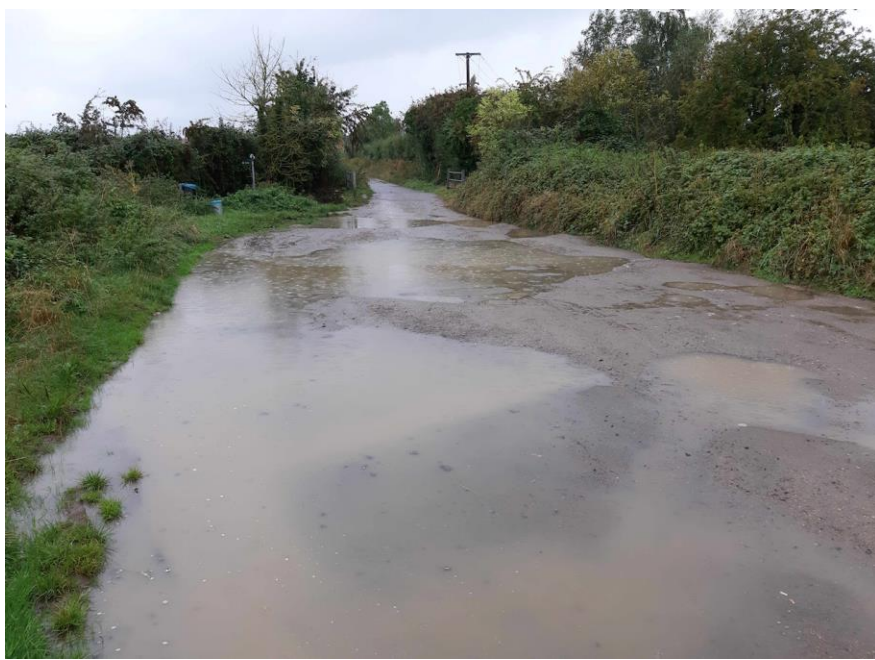
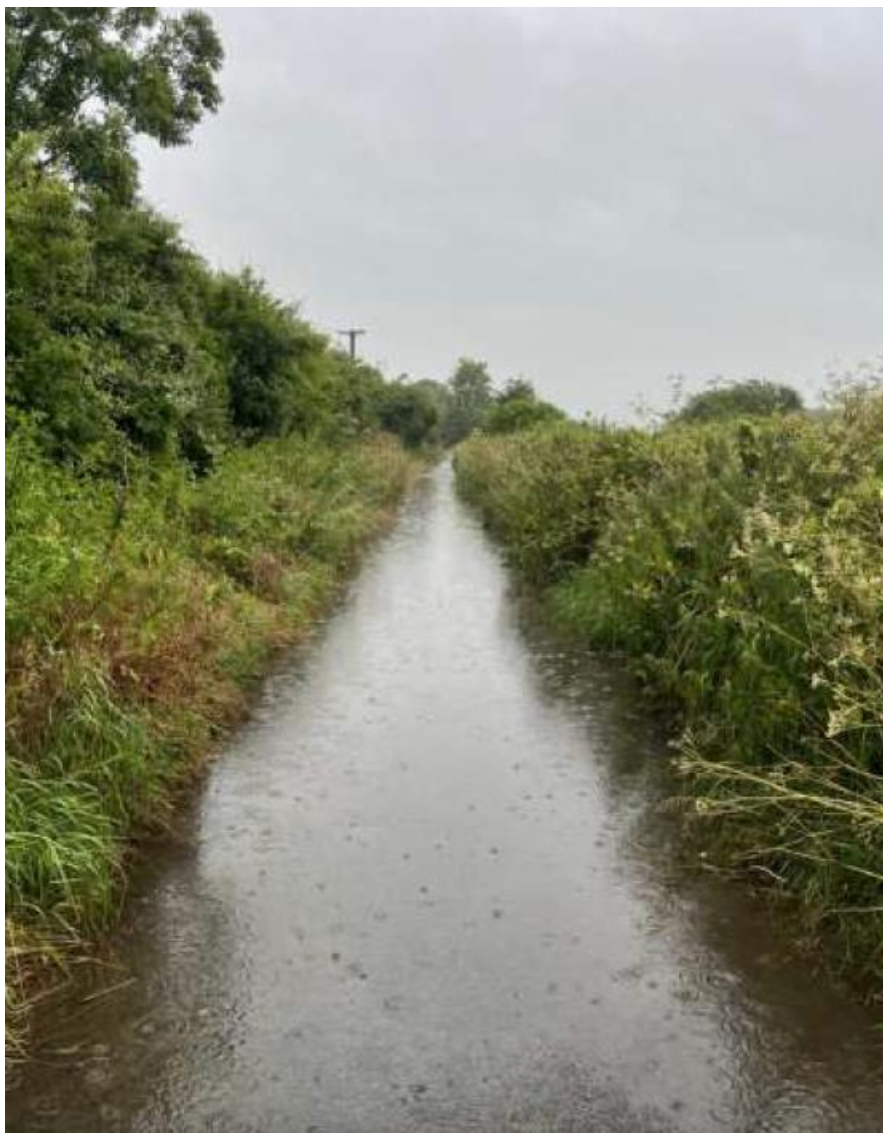
Below are some photos of this 'Very Low' flood risk:

These photos are not unusual. This route floods almost every year & on occasion adult pedestrians wearing full height wellington boots cannot transit the bridleway as the water is too deep.

The property itself is indicated to be unaffected by flooding now or in the future. However, flooding is indicated on a discrete section of Horsecroft (lane) as it passes over the Frogmore Brook, with the site access situated within Flood Zone 3a and with further investigation required

The map provided at para 3.16.2 shows that the access road/bridleway of Horsecroft is at high risk of flooding

The flood risk to the access road is also indicated to be Very Low, with no flood mitigation proposed and with residual risks concluded to be suitably discharged via flood management, as outlined below.

The alternative route for vehicles proposed by the Applicant in the Transport Statement (para 4.3.4) is extremely tenuous too in wet weather without a 4 wheel drive vehicle. Additionally pre-booked delivery vehicles, postal and refuse disposal vehicles will attempt to use the flooded Horsecroft route and either get stuck or cause considerable verge damage trying to reverse long distances through a flood on a very narrow tarmac surface.
